# Manhole Inspection Summary

Manhole # S09OO\_029MH

Insp Date: **8/13/07 1:23 PM**

**Location** Address: **DENISON AVE**

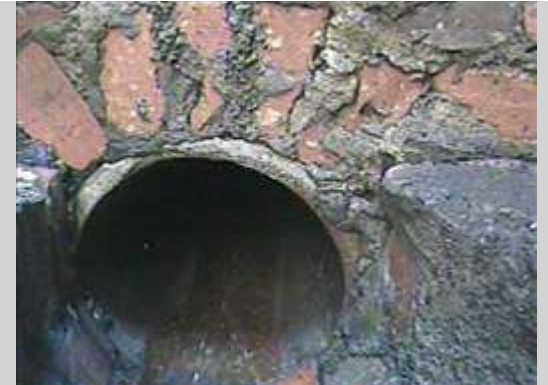
12 O'Clock Outflow

8 in. Circular Gravity Sewer  
Pipe Out @ 12 O'Clock

Pipe Height: (in.) Direct  
Pipe Material: **Clay** ☐ Pipe Lined  
Invert Depth: **8.20** (ft.) Flow Characteristics: **Slow**  
Deposits: ☒ None ☐ Mud ☐ Sludge ☐ Debris ☐ Grease  
Silt Depth: (in.) Deposits Extent:  
Infiltration: **None** Pipe Seal Cond: **Cracked**

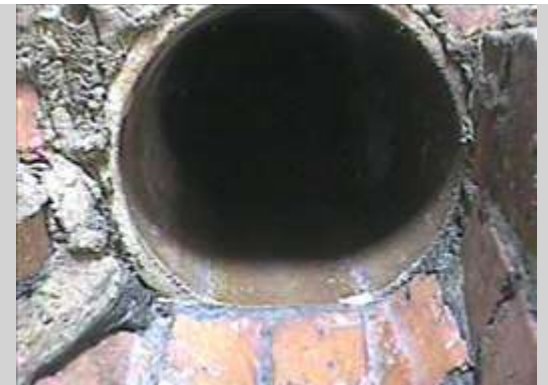
3 O'Clock Inflow

8 in. Circular Gravity Sewer  
Pipe In @ 3 O'Clock

Pipe Height: (in.) Direct  
Pipe Material: **Clay** ☐ Pipe Lined  
Invert Depth: **7.79** (ft.) Flow Characteristics: **Slow**  
Deposits: ☒ None ☐ Mud ☐ Sludge ☐ Debris ☐ Grease  
Silt Depth: (in.) Deposits Extent:  
Infiltration: **None** Pipe Seal Cond: **Sound**

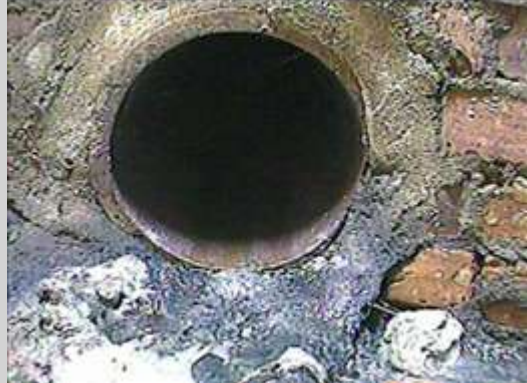
8 O'Clock Inflow

8 in. Circular Gravity Sewer

Pipe In @ 8 O'Clock

Infiltration: **None** Pipe Seal Cond: **Sound**
